Vertical Plate Technology Extends the Life of Coke Drums

A method for eliminating circumferential welds addresses a historical problem with coke drums

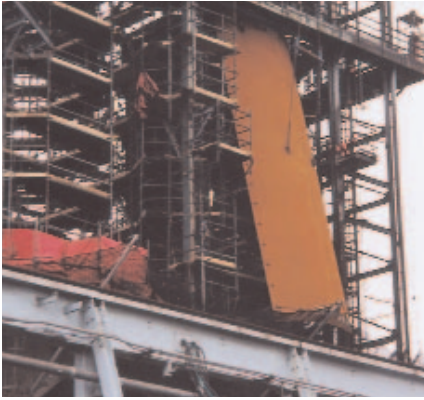
Fig. 5 — Replacement of a vertical section of a coke drum.

ment of a 35-ft vertical section on a 10-year-old coke drum, was completed on a turnaround basis in 16 days — Fig. 5. For this project, CB&I utilized its can section replacement method. This particular vessel had experienced excessive bulging and cracking in 60% of its circumferential welds. Its shell courses were replaced with new 35-ft-long plates arranged vertically in four sections. Braces were also added to the vessel stairwell and the drum was insulated.
